Manhole Inspection Summary

Manhole # S25A__016MH

Insp Date: **8/17/07 12:57 PM**

Location Address: **1137 HARLEM-EDMONDSON** Cross Street: **CARROLTON AVE**

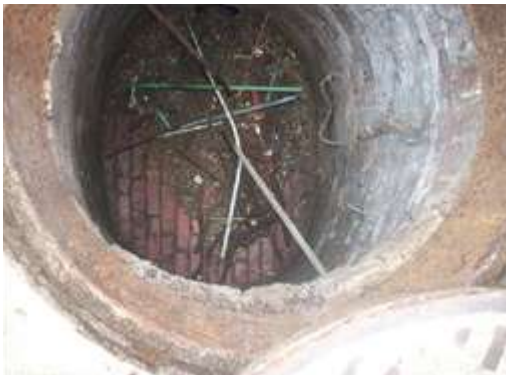
Defect 1

Frame Offset: **1** (in.) Condition: ☒ Sound ☐ Cracked ☐ Leaks

Steps Count: **0** Missing: **4** ☐ Corroded

FRAME OFFSET AND MISSING STEP

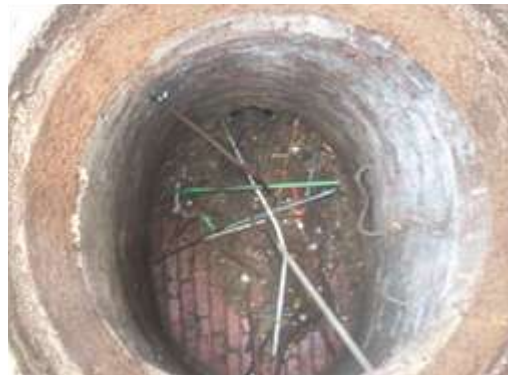
Defect 2

Corbel Material: **Brick** ☐ Parged Type: **Concentric/Eccentric**

Condition: ☐ Sound ☐ Cracked ☐ Root Intrusion ☐ Loose Brick ☒ **Deteriorated**

DETERIORATED CORBEL

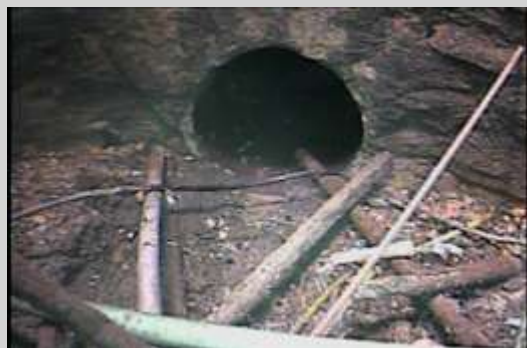
12 O'Clock Outflow

8 in. Circular Gravity Sewer
Pipe Out @ 12 O'Clock

Deposits: ☐ None ☐ Mud ☐ Sludge ☒ **Debris** ☐ Grease

Silt Depth: **2** (in.) Deposits Extent: **Light**
